June 28, 2019
File No. 262018.063

Subject: Department of Natural Resources Washington Geological Survey,
School Seismic Safety Assessment Project, Contract No. AE 410 -
Seismic Evaluation for **Bickleton School District**

Building Name:	Bldg B - Vocational/Transportation
Facility Name:	Bickleton Elementary and High School
District Name:	Bickleton
ICOS Latitude:	45.999
ICOS Longitude:	-120.293
ICOS County/District ID:	20203
ICOS Building ID:	23173
ASCE 41 Bldg Type:	S3
Enrollment:	87
Gross Sq. Ft. :	3,672
Year Built:	1961
Number of Stories:	1
S _{XS} BSE-2E:	0.329
S _{X1} BSE-2E:	0.135
ASCE 41 Level of Seismicity:	Low
Site Class:	B
V _{S30} (m/s):	1031
Liquefaction Potential:	None
Tsunami Risk:	None
Structural Drawings Available:	No
Evaluating Firm:	WRK Engineers

Building Name:	Main Building
Facility Name:	Bickleton Elementary and High School
District Name:	Bickleton
ICOS Latitude:	45.999
ICOS Longitude:	-120.293
ICOS County/District ID:	20203
ICOS Building ID:	23171
ASCE 41 Bldg Type:	RM2
Enrollment:	87
Gross Sq. Ft. :	39,330
Year Built:	2010
Number of Stories:	1
S _{XS} BSE-2E:	0.329
S _{X1} BSE-2E:	0.135
ASCE 41 Level of Seismicity:	Low
Site Class:	B
V _{S30} (m/s):	1031
Lique

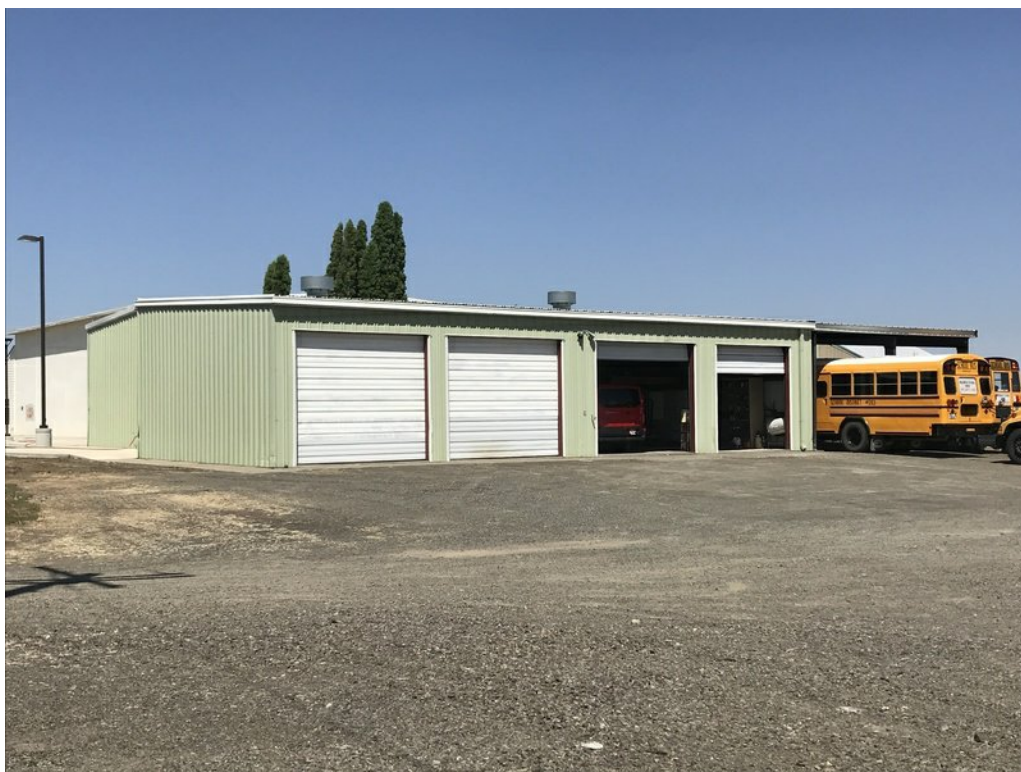
Figure 1-1. Bickleton Vocational/Transportation Building - Southwest Exterior

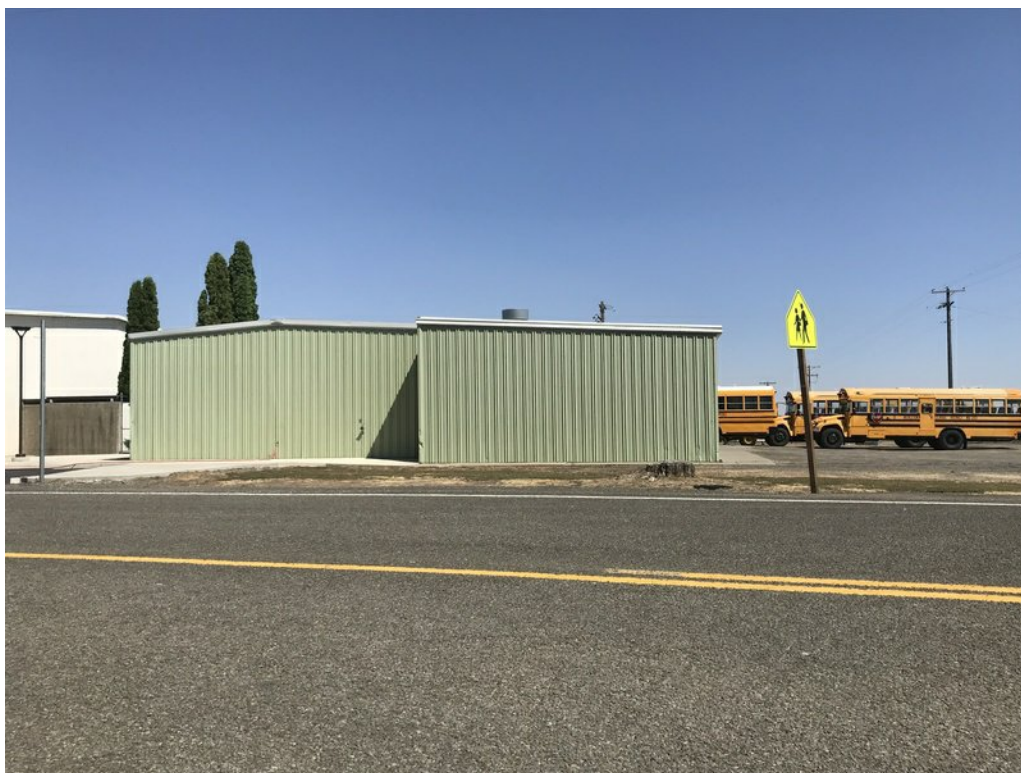
Figure 1-2. Bickleton Vocational/Transportation Building - South Exterior

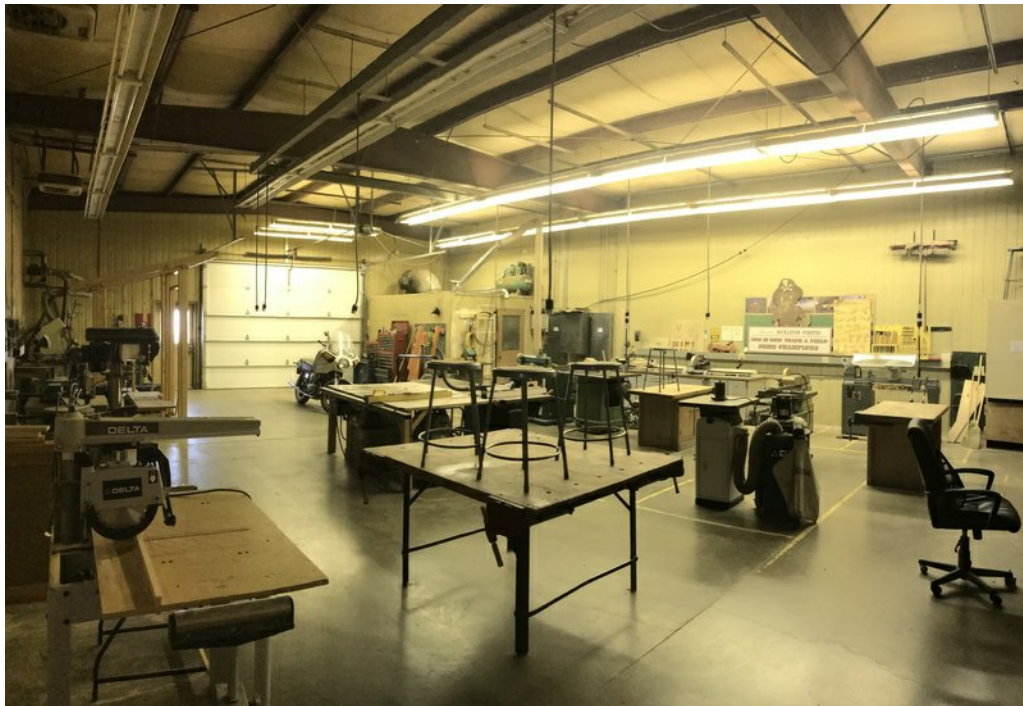
Figure 1-3. Shop Room - South Side

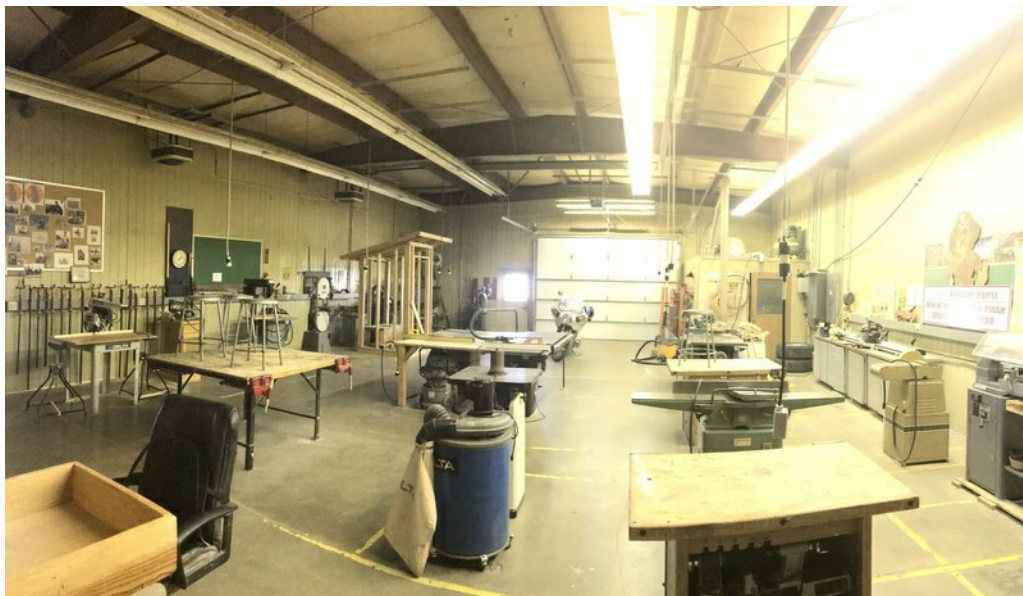
Figure 1-4. Shop Room - North Side

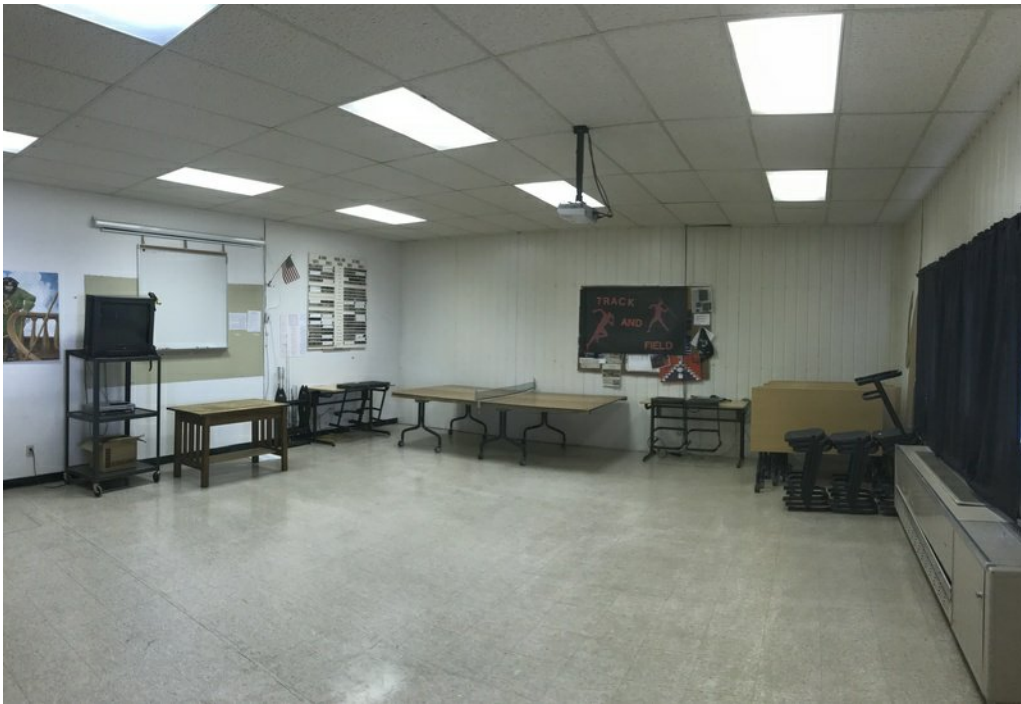
Unknown Item	Description
LF-1 Independent Support. HR-not required; LS-MH; PR-MH.	Further investigation required to review support system for light fixtures. Based on the age of the building, this item is likely non-compliant. Installation of light fixture bracing may be appropriate to mitigate seismic risk.
CG-2 Cladding Isolation. HR-not required; LS-MH; PR-MH.	Further investigation required to verify cladding connection detailing.
CG-5 Panel Connections. HR-MH; LS-MH; PR-MH.	Further investigation required to verify cladding connections.
CG-6 Bearing Connections. HR-MH; LS-MH; PR-MH.	Further investigation required to verify cladding connections.
S-2 Stair Details. HR-not required; LS-LMH; PR-LMH.	Further investigation required to verify stair connections.

Figure 1-5. Classroom with Unknown Bracing for Light Fixtures

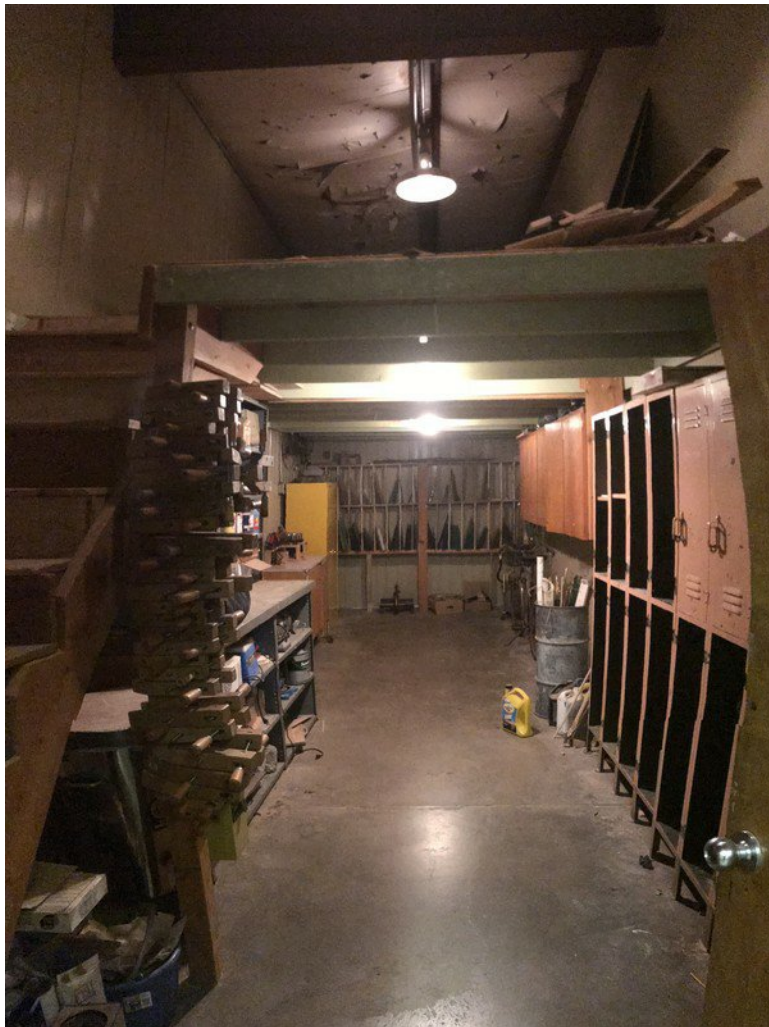
Figure 1-6. Storage Room with Unbraced Lockers

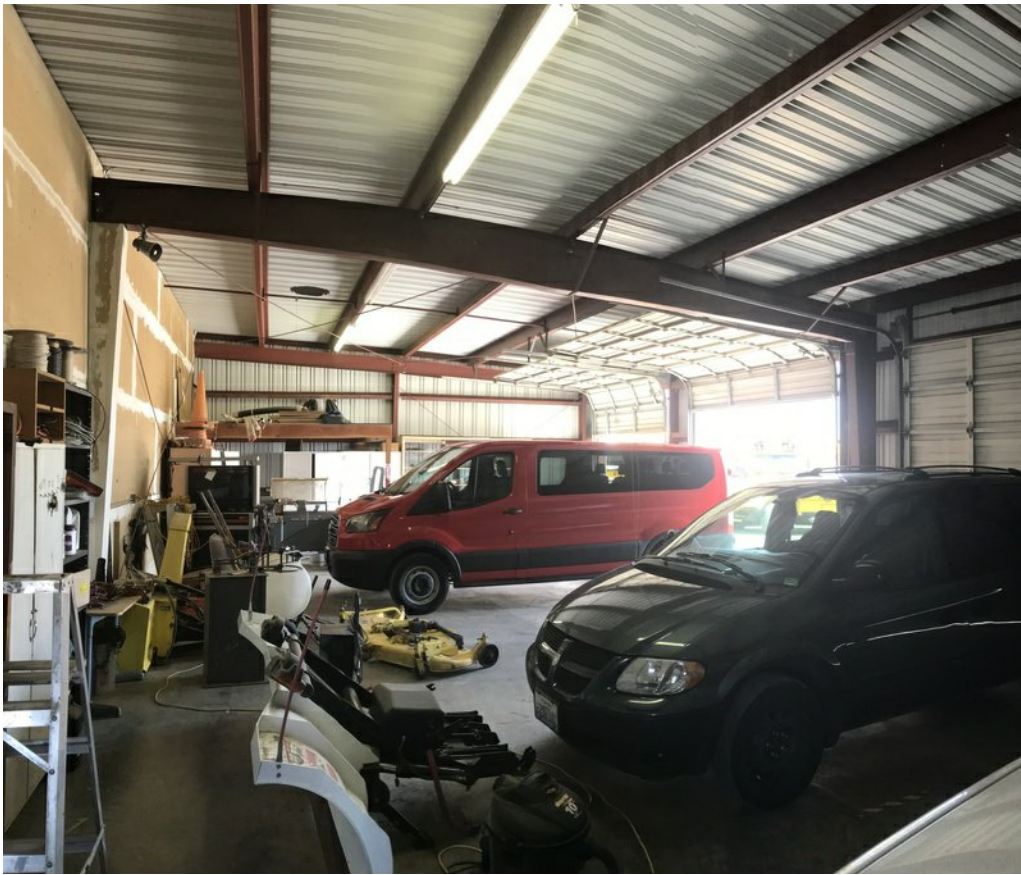
Figure 1-7. Garage Addition - East Side

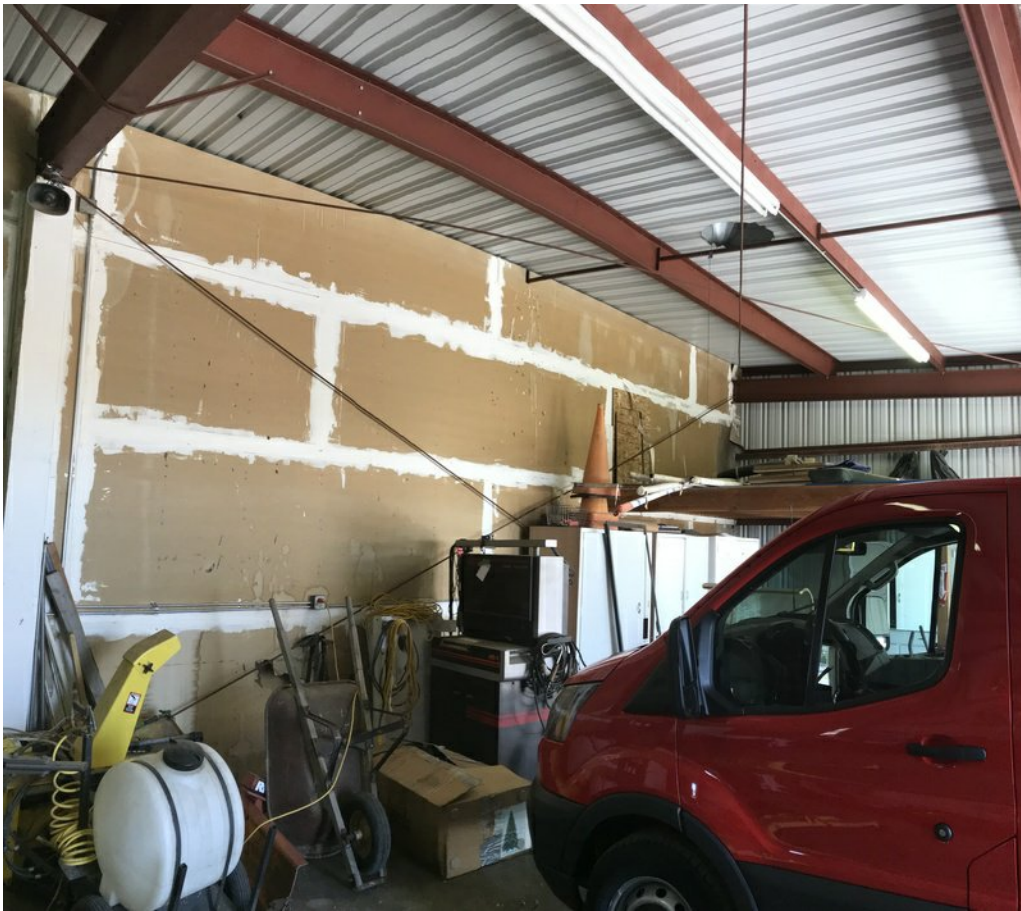
Unknown Item	Description
Load Path	Limited structural drawings are available. Unknown if connection between rod bracing and structure is adequate. No clear connection to foundation. Further investigation is required to make a final determination on this item's compliance.
Liquefaction	The liquefaction potential of site soils is unknown at this time given available information. Bedrock liquefaction potential is identified per ICOS based on state geologic mapping. Requires further investigation by a licensed geotechnical engineer to determine liquefaction potential.
Slope Failure	Requires further investigation by a licensed geotechnical engineer to determine susceptibility to slope failure.
Surface Fault Rupture	Requires further investigation by a licensed geotechnical engineer to determine whether site is near locations of expected surface fault ruptures.

Figure 1-8. Garage Addition - North Side with Diagonal Rod Bracing

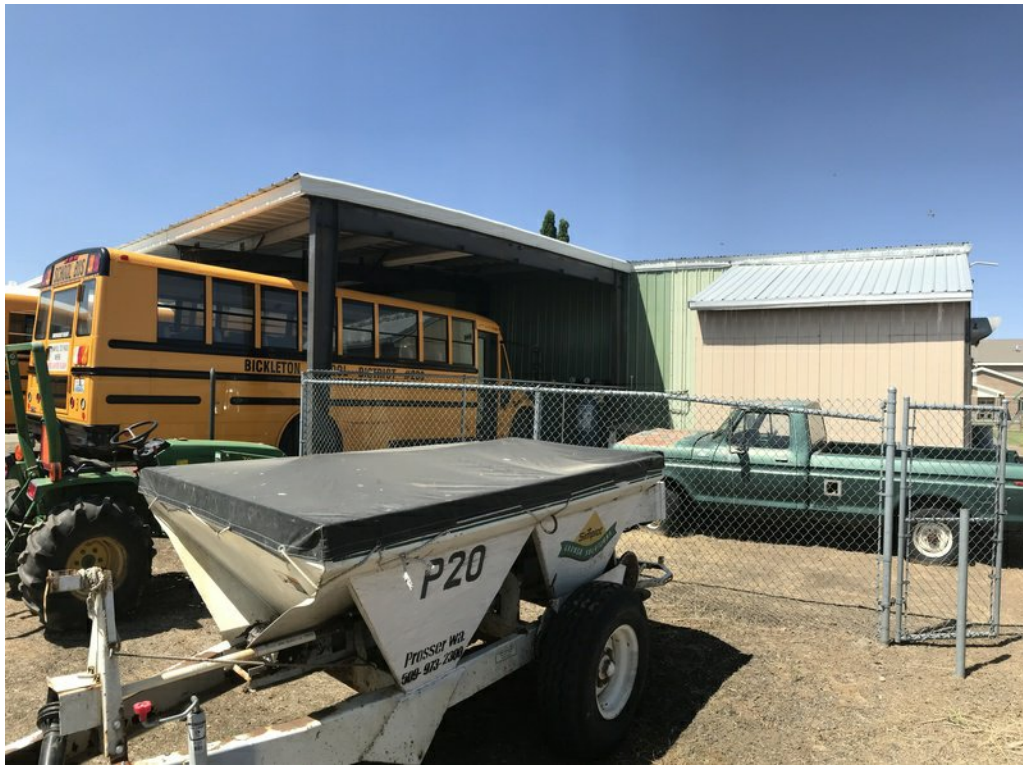
Figure 1-9. Covered Area at Garage

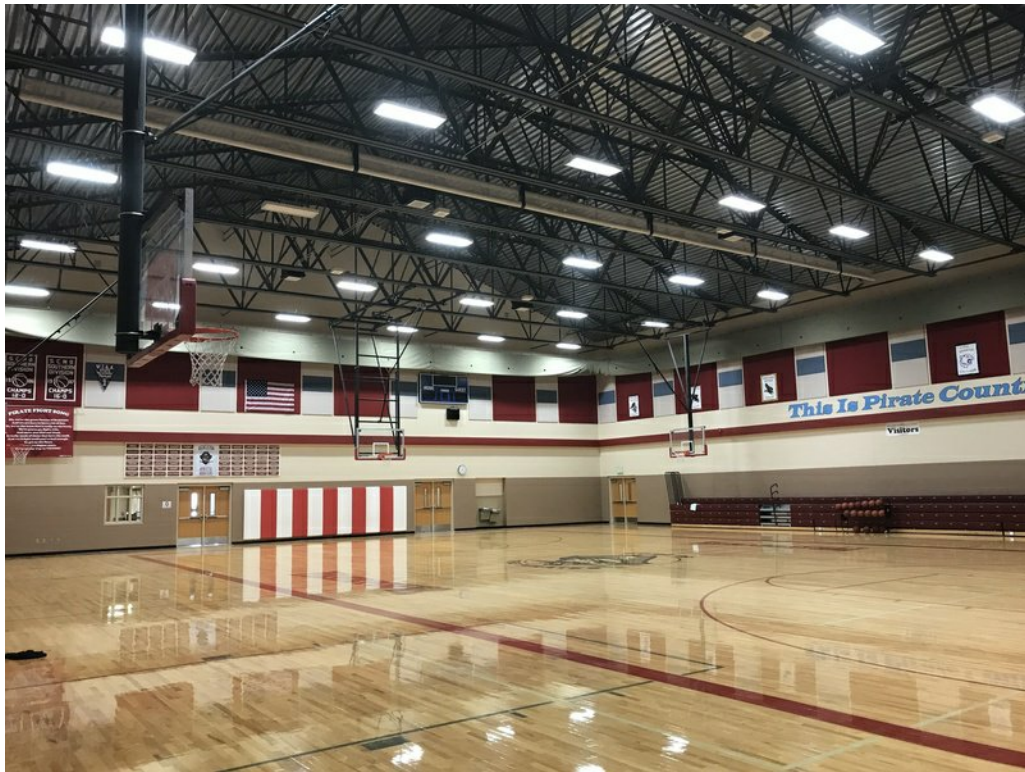
Figure 1-1. Gymnasium with Steel Truss and Metal Deck Diaphragm Roof System

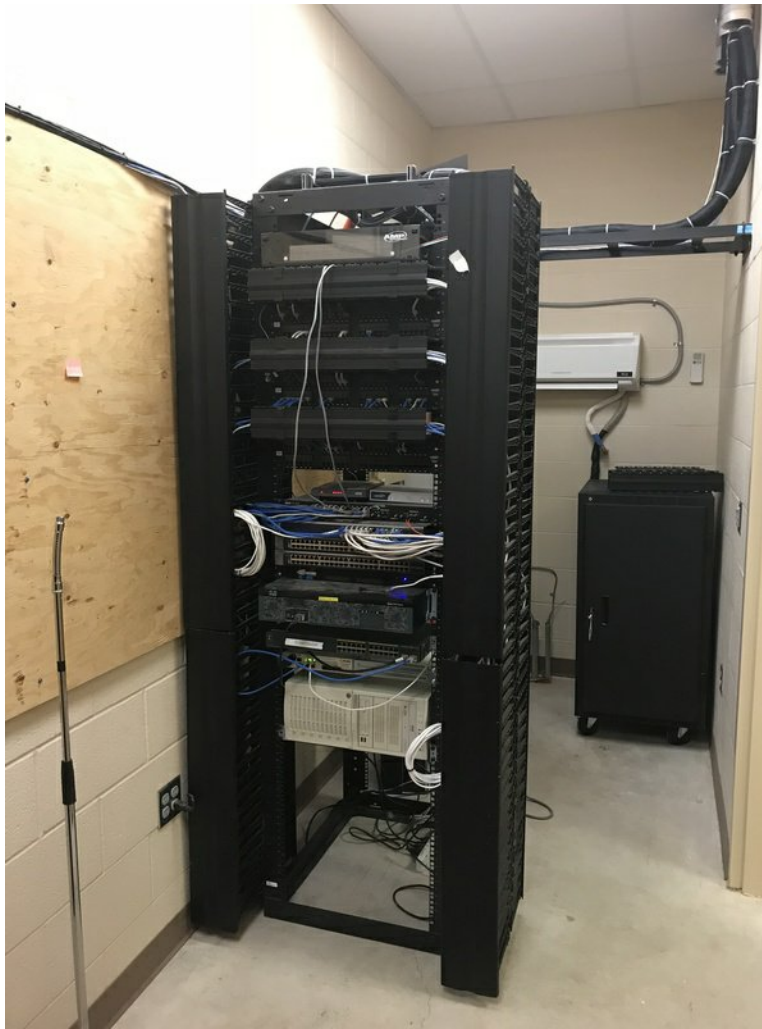
Figure 1-2. Server Room. Unbraced Tall Nonstructural Components Typical.

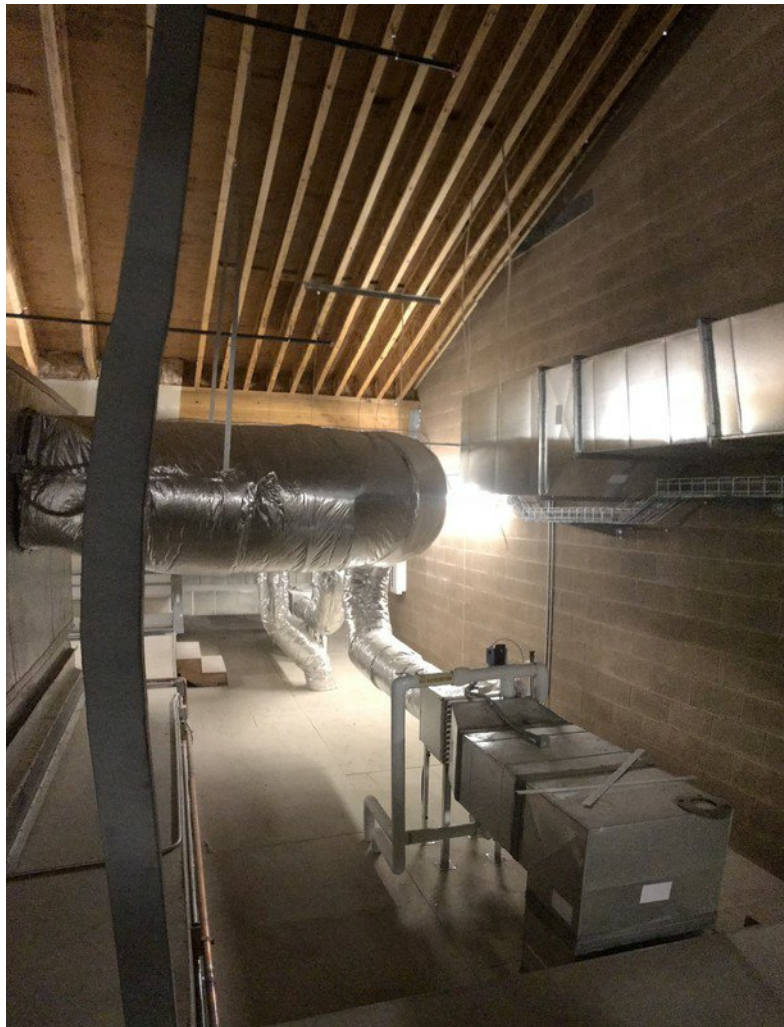
Figure 1-3. Interstitial Level

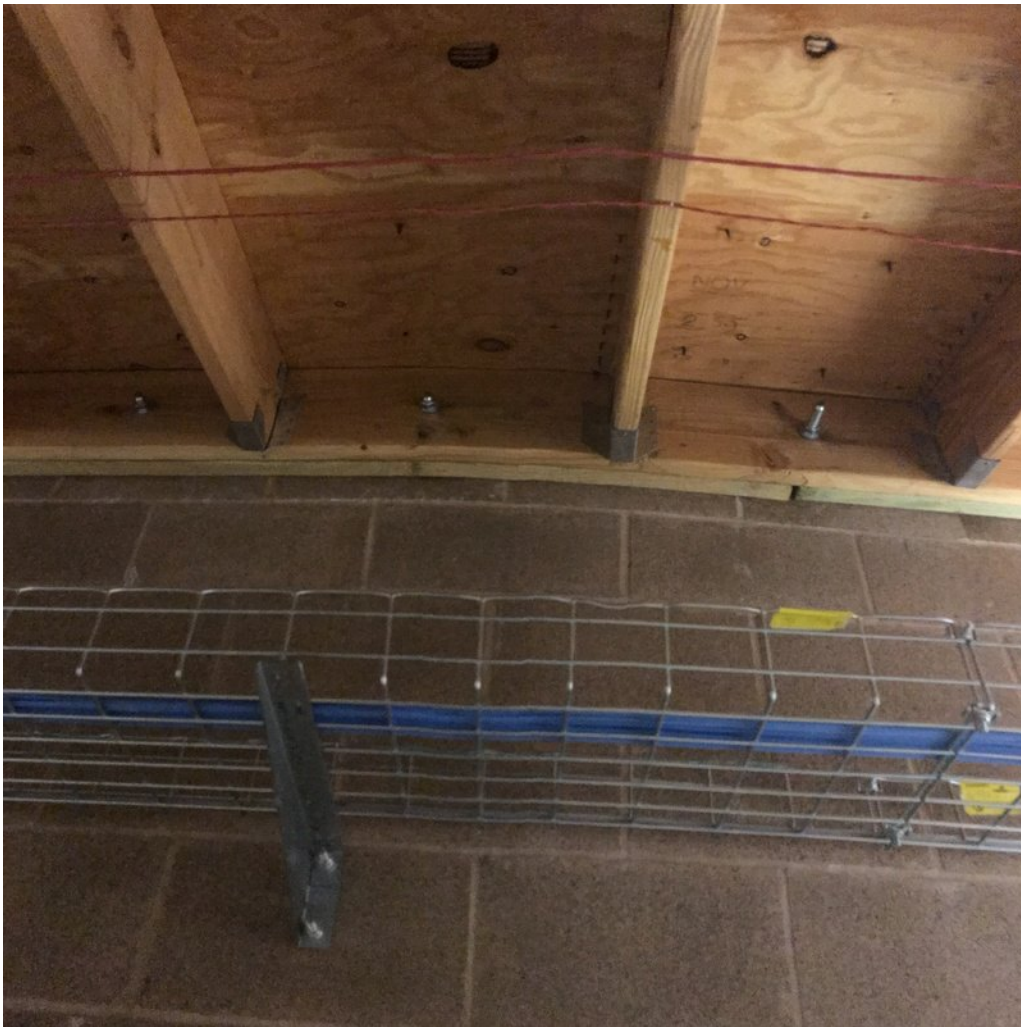
Figure 1-4. Typical Diaphragm Connection to CMU Wall

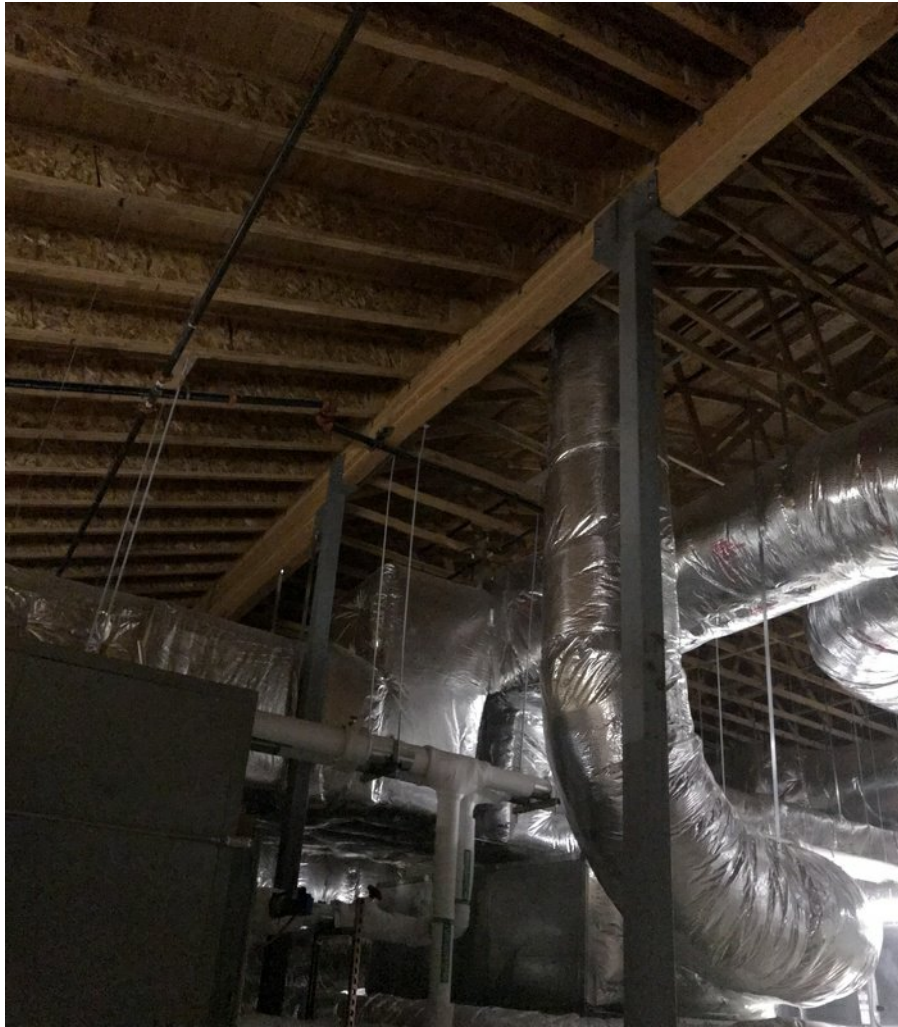
Figure 1-5. Interstitial Level Showing Roof Framing

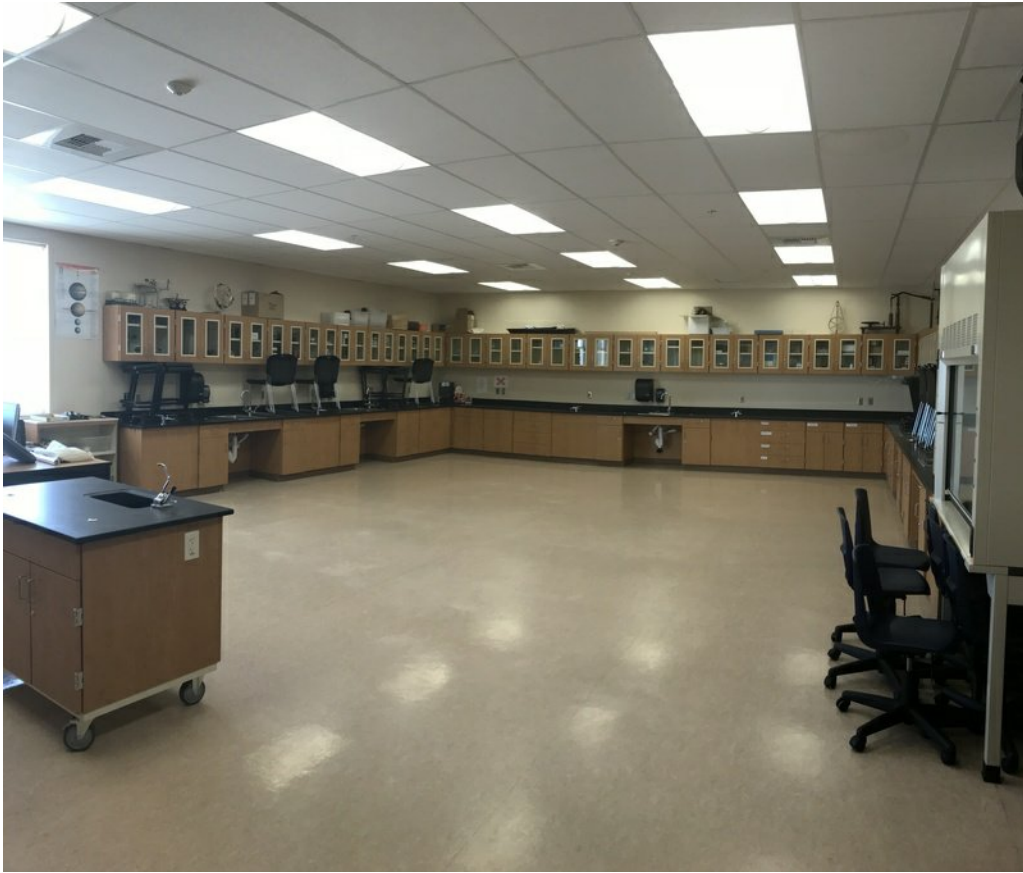
Figure 1-6. Typical Lab Classroom with Unknown Light Fixture Bracing

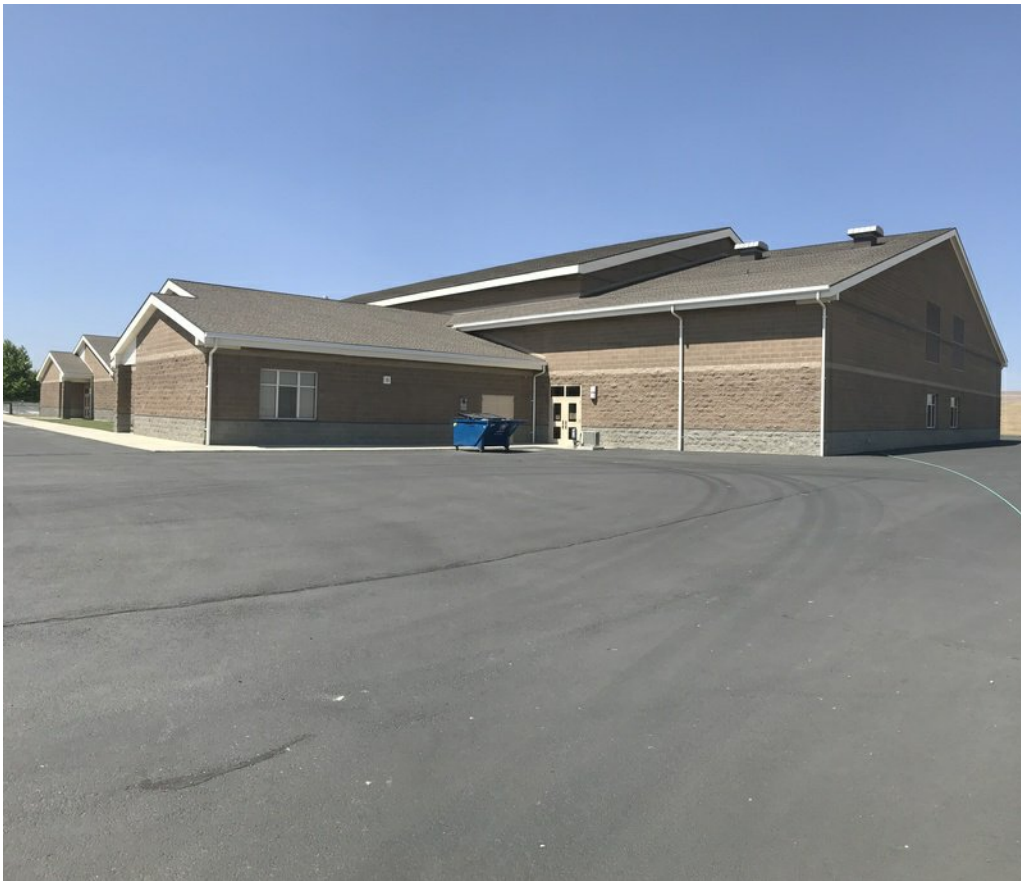
Figure 1-7. Bickleton Elementary and High School - Southeast Exterior

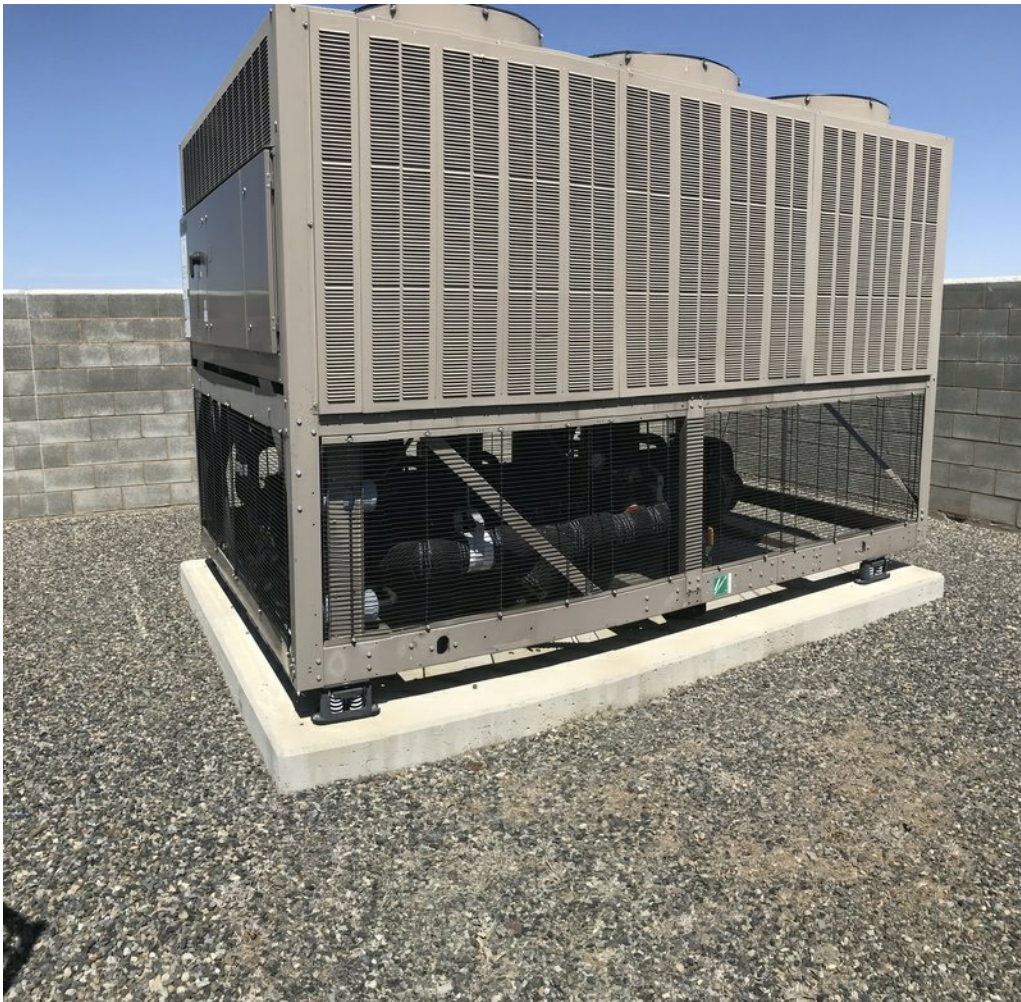
Figure 1-8. Mechanical Equipment Unbraced

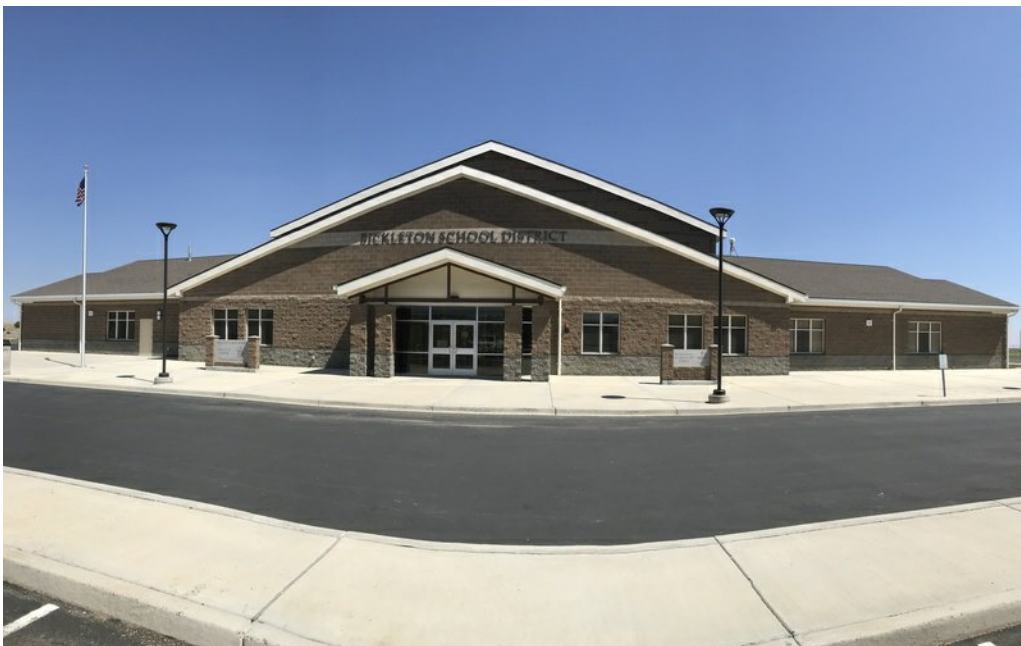
Figure 1-9. Bickleton Elementary and High School - West Exterior

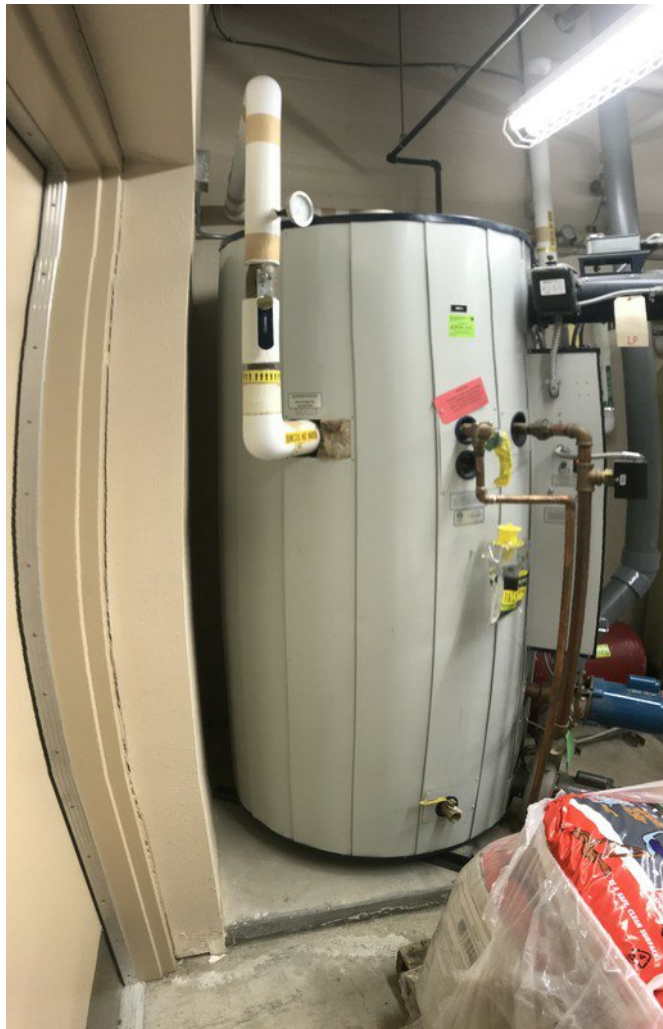
Figure 1-10. Mechanical Room with Unbraced Equipment
